(Trouble shooting the Rod Knuckle)

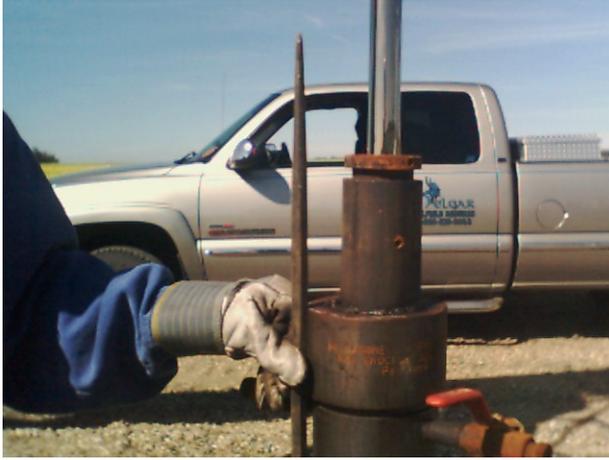
Above misalignment is easy to see before anything is taken apart and may be the problem.

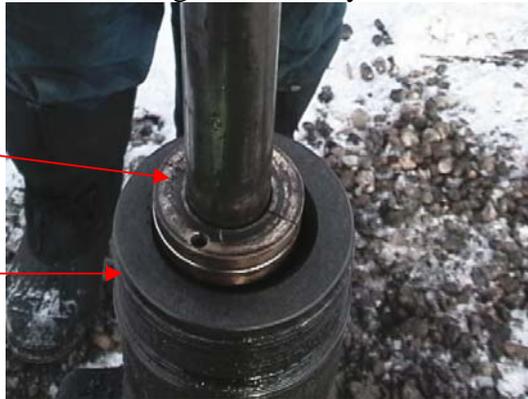
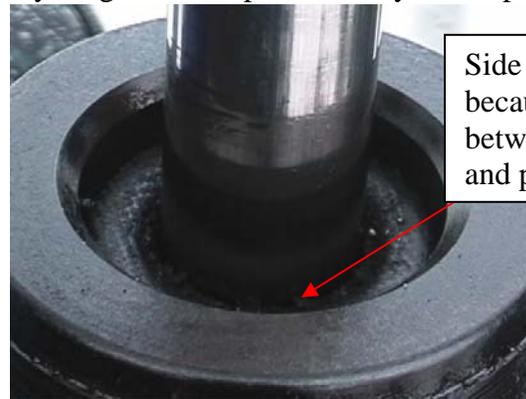
Side load is evident because of gap between polish rod and packing.

This can be caused by miss alignment either by well head or pump jack as you can see the picture on the right the gap between the polish rod and the bottom packing; this picture shows pump jack misalignment. After we took the 4 rings of packing out and the bottom split ring you can see on the left picture much the well is out of alignment. All the brass components in the Rod Knuckle are design help straighten the rod so it goes in a parallel motion when going inside the well head. The brass components were also designed to eliminate wear on the side of the stuffing box which decreases rod breakages and polish rod scoring. So if there is wear on any of the parts you will have to replace them before installing new packing or it will wear-out packing prematurely in the Rod Knuckle. Rod Knuckle alignment is key to its success and should be maintained daily by operations staff. The Rod Knuckle was designed so that it is easy to see if the pumping unit and the wellhead are lined-up properly. If you can see misalignment as in the top picture then the polished rod is bending with each stroke which will cause premature failures on Packing, components and polished rods.

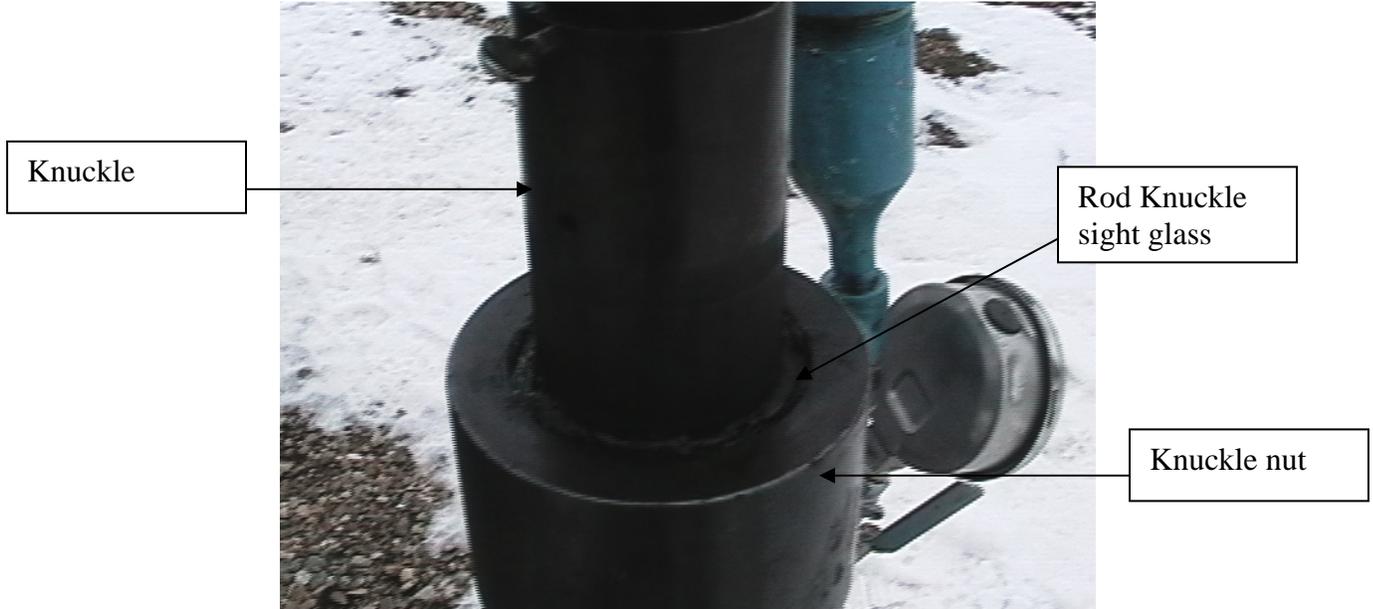
It is simple! By using the “sight glass” built into the Rod Knuckle. This should be used as an **alignment tool not an alignment fix**. The gap around the Knuckle and top of the Knuckle nut should be the same all around and should be used to maintain alignment on a daily bases.

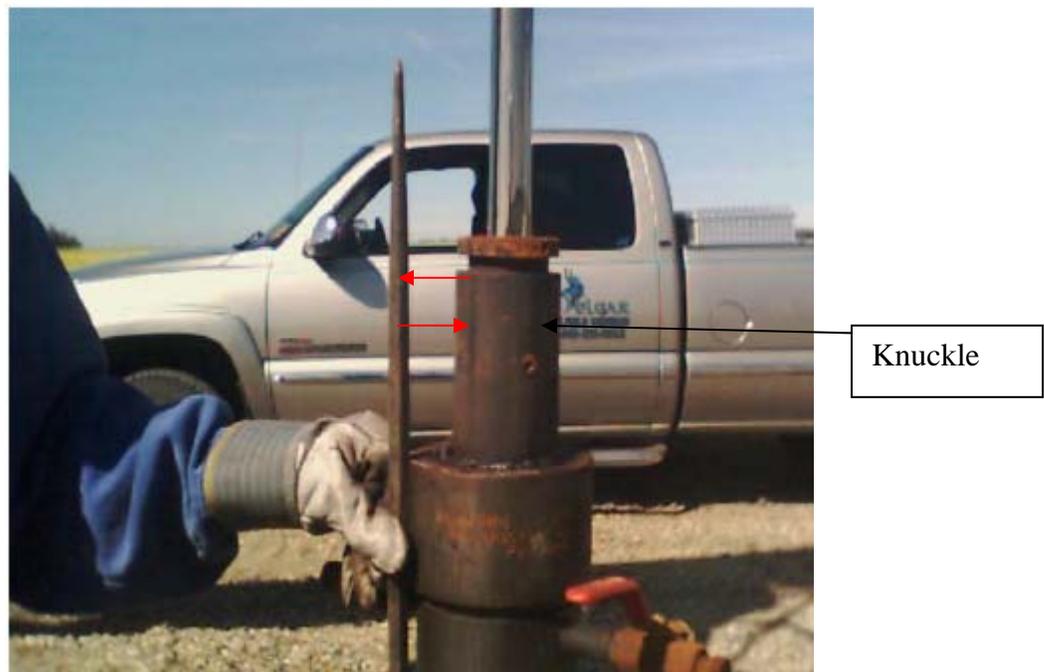
Here is an example on how easy it is to visually maintain alignment (see in the above picture). This picture shows extreme side load on the lower (primary) packing and parts. Eventually the lower parts wear-out and the lower Rod Knuckle packing becomes impossible to seal over the long term until the worn parts are replaced. The Knuckle (RK7883-025) and upper (secondary) packing was designed to follow the polish rod wherever it goes so that when the

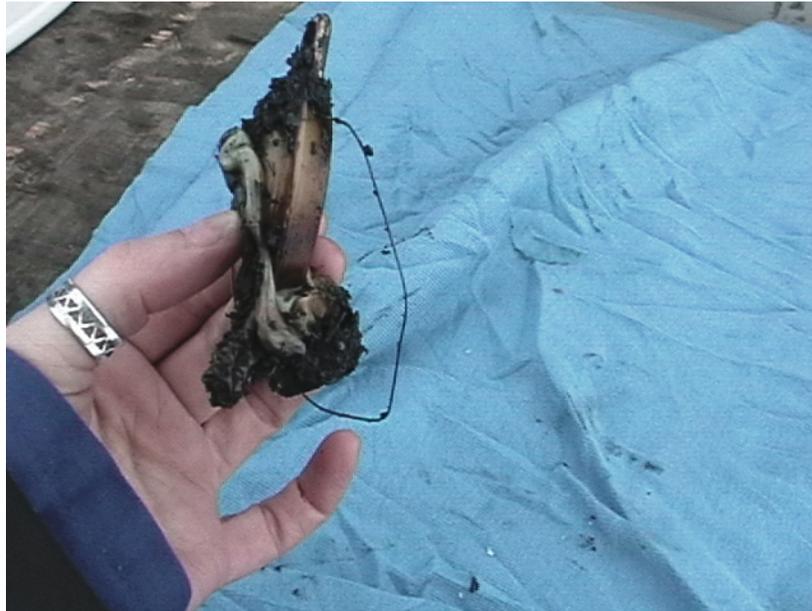
This problem only occurs on wells with fluid pumping problems (i.e. the problem is the well does not pump enough fluid to cool and lubricate the polished rod). The regular service check valves are resistant to corrosion and have a melting point of 178°C or 352°F . This temperature should not occur in a conventional well if the pump is functioning properly. If melting is a problem the well needs to be optimized (i.e. Dynamometer and fluid level to find the problem). Please note there are different check-valve and packing materials available for every application.

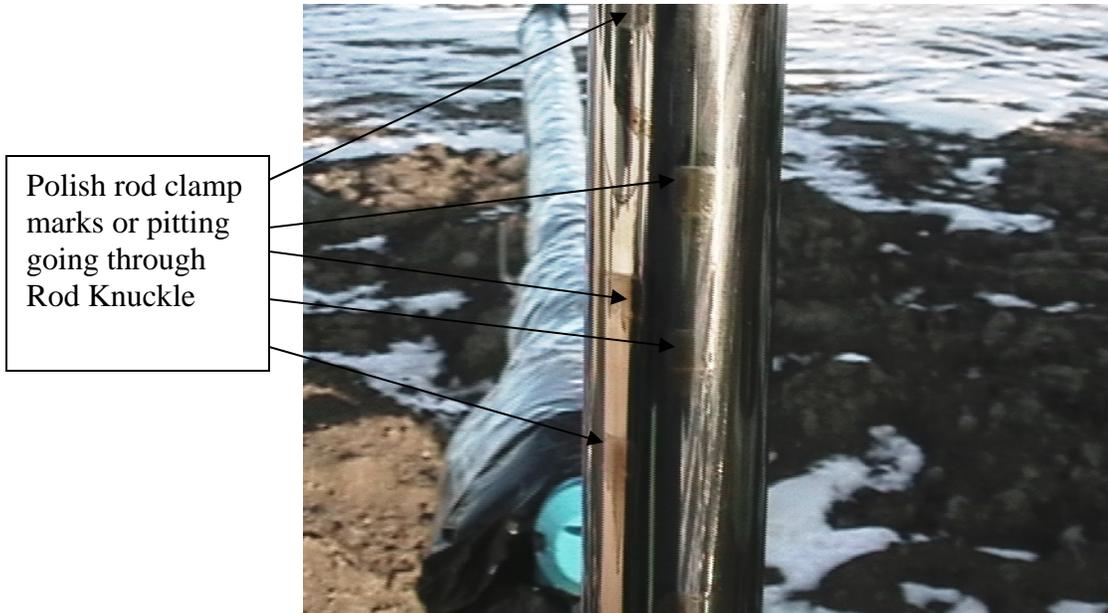
Polish Rod condition is another factor in running any type of stuffing box. If you see severe rod clamp marks (caused by over tightening of the rod clamps), bubbled, scored or pitted polished rod it should be changed out. A polish rod with any of these flaws will decrease packing life and cause any packing to leak or seep slightly.
